ASBESTOS REINSPECTION SURVEY
OF
UNIT 19 CORNISH WAY, NORTH WALSHAM, NORFOLK, NR28 0AW

CLIENT: NORTH NORFOLK DISTRICT COUNCIL
COUNCIL OFFICES, HOLT ROAD, CROMER, NR27 9EN

UPRN NO: N/A
PROJECT NO: J926554
DATE: February 2024

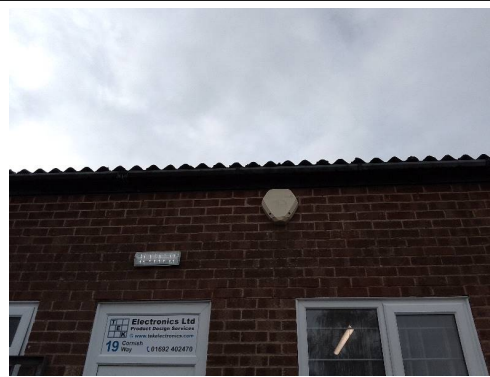
BUILDING NAME:	Main Building
FLOOR/LOCATION:	External
DESCRIPTION:	Cement corrugated roofing sheets
RECOMMENDATIONS:	Manage, monitor and inform maintenance personnel prior to relevant works
EXTENT:	>50m ² or >50m pipe run
SAMPLE REF:	CM003 {UL000091}
RESULT:	Chrysotile

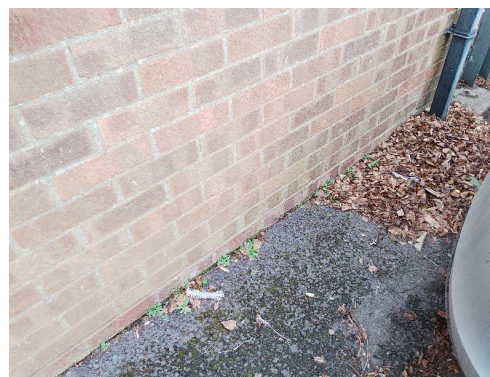
BUILDING NAME:	Main Building
FLOOR/LOCATION:	External
DESCRIPTION:	Damp proof course
RECOMMENDATIONS:	Manage, monitor and inform maintenance personnel prior to relevant works
EXTENT:	10 - 50 m ² or 10 - 50m pipe run
SAMPLE REF:	CM004 {UL000092}
RESULT:	Chrysotile

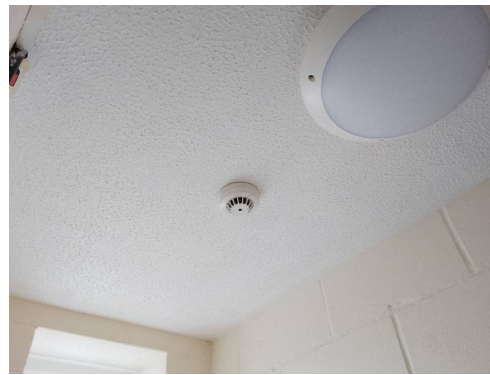
BUILDING NAME:	Main Building
FLOOR/LOCATION:	Ground Floor WC
DESCRIPTION:	Textured coating to ceiling
RECOMMENDATIONS:	Manage, monitor and inform maintenance personnel prior to relevant works
EXTENT:	<10m ² or <10m pipe run
SAMPLE REF:	CM001 {UL000090}
RESULT:	Chrysotile

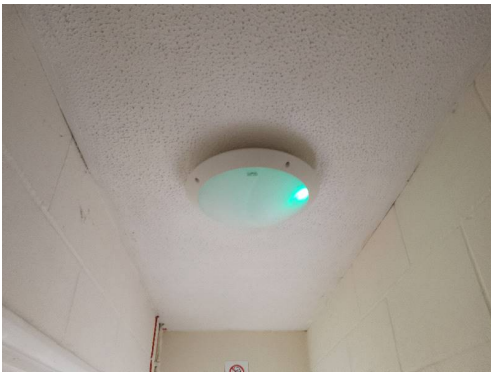
BUILDING NAME:	Main Building

FLOOR/LOCATION:	Ground Floor Entrance Lobby	
DESCRIPTION:	Textured coating to ceiling	
RECOMMENDATIONS:	Manage, monitor and inform maintenance personnel prior to relevant works	
EXTENT:	<10m² or <10m pipe run	
SAMPLE REF:	SPST CM001 {UL000090}	
RESULT:	Chrysotile

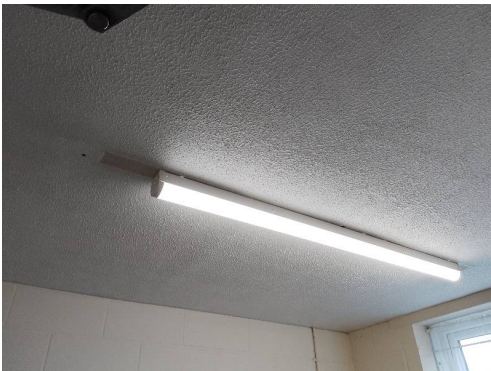
BUILDING NAME:	Main Building

FLOOR/LOCATION:	Ground Floor Office	
DESCRIPTION:	Textured coating to ceiling	
RECOMMENDATIONS:	Manage, monitor and inform maintenance personnel prior to relevant works	
EXTENT:	<10m² or <10m pipe run	
SAMPLE REF:	SPST CM001 {UL000090}	
RESULT:	Chrysotile
