Brinton

Conservation Area Appraisal and Management Plan

July 2022

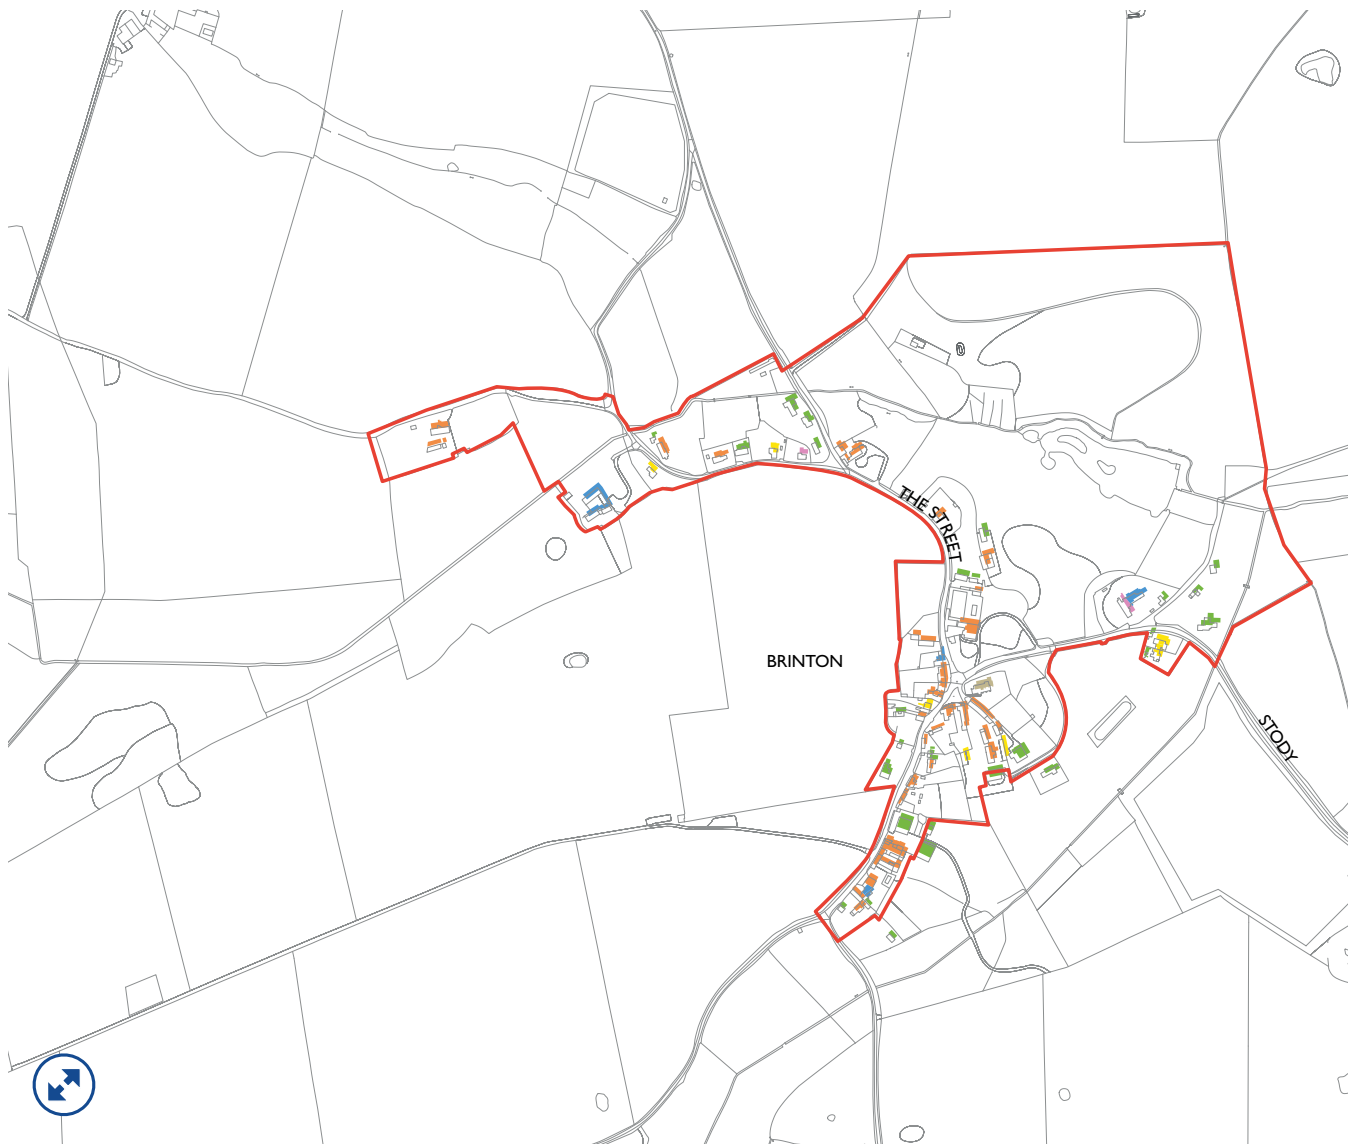
This plan indicates the age of the existing built fabric of the main buildings and structures in Brinton. It is mostly based on a comparison of historic maps with limited verification through viewing of the existing building from the street. Some buildings may have been constructed in phases but generally only the main phase is shown here. Some buildings may have been partially rebuilt or substantially repaired since they were first built but their footprint was unchanged and so the change is not obvious in map comparisons. Where this is the case, generally the building is coloured for the earliest date that it appears on the map.

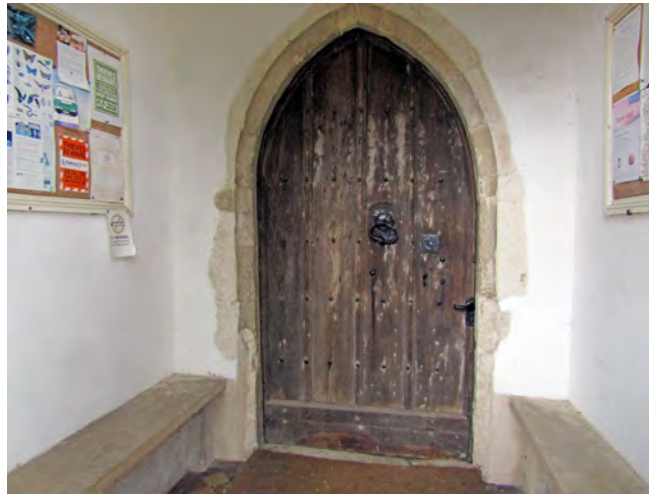
Front door to church located in porch on the south elevation

The only place of worship in the village and a landmark building, St Andrew's Church has courses of rubble and knapped flints in the walls and flint galletting in areas on the north and west elevations of the building, reflecting to its high status. There are also stone surrounds on the windows, doors and large ashlar stone quoins on the corners of the building and on the stepped buttresses. A mix of stained glass and plain leaded light windows illuminate the building with exceptional examples of stained glass on the north elevation. The church is grade I listed and has fabric from the fourteenth century with nineteenth century alteration and additions.

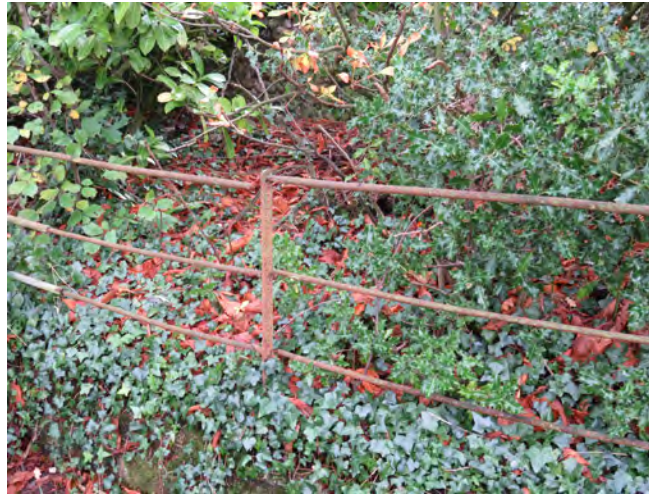
Broken and corroding railings

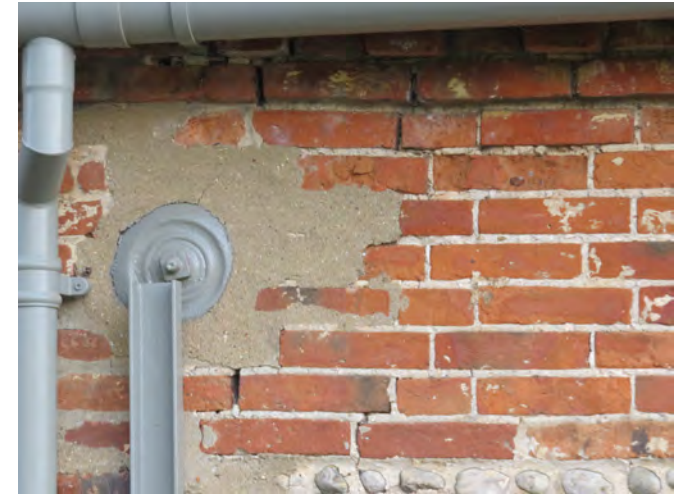
Cementitious repointing to brickwork

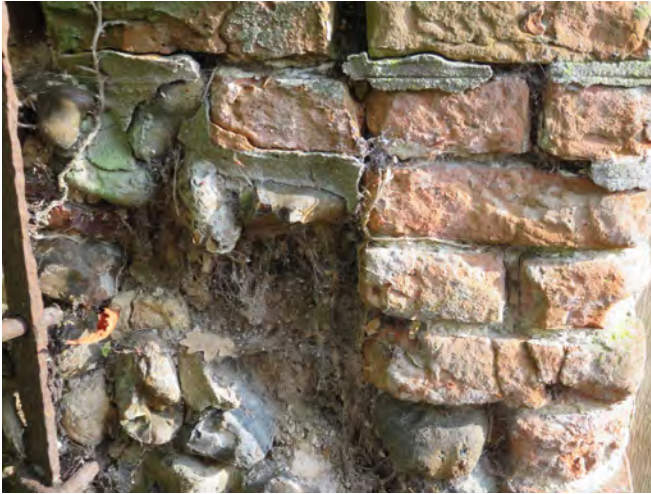
Cementitious repointing, missing flints and damaged bricks to a historic boundary wall

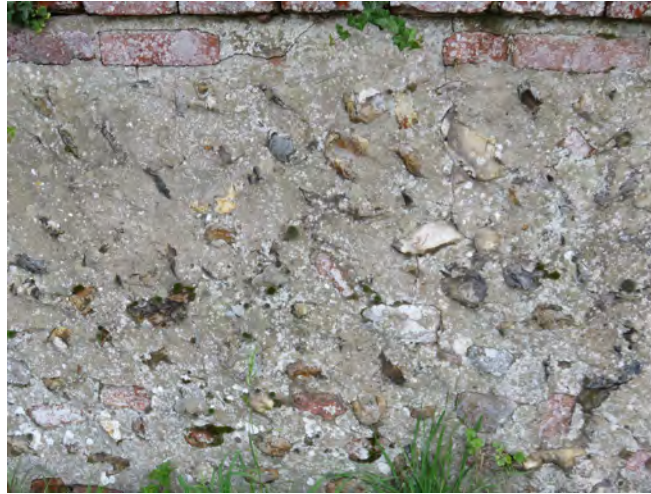
Excessive repointing to flint wall

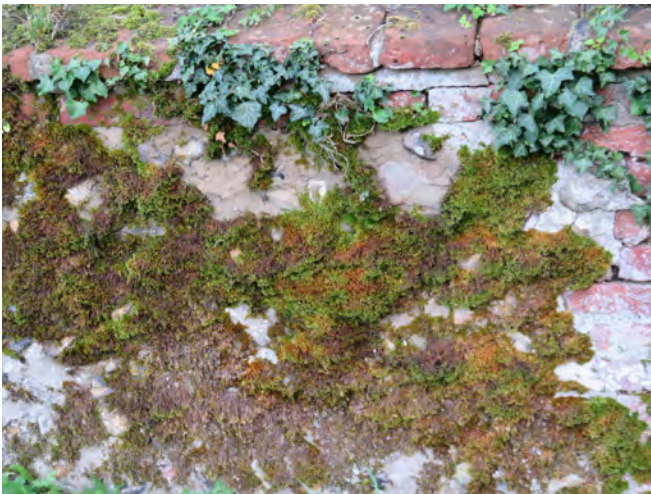
Vegetation growth on a historic wall and loss of flints

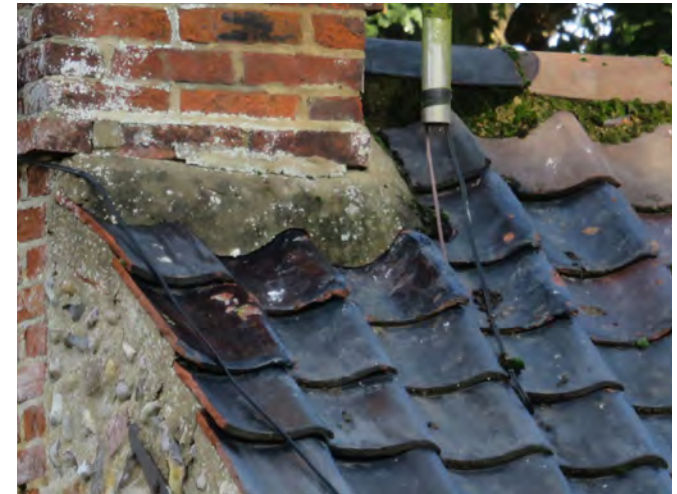
Inappropriate cementitious repairs to chimney and roof

The rendering of buildings which were traditionally exposed brick is not appropriate as this also traps moisture and reduces the breathability of buildings. Traditional lime mortar should be used for renders to historic buildings if they are deemed appropriate. The painting of brickwork is not normally good conservation practice, as plastic paints also reduce breathability. Breathable traditional paints are therefore preferable to modern plastic paints.

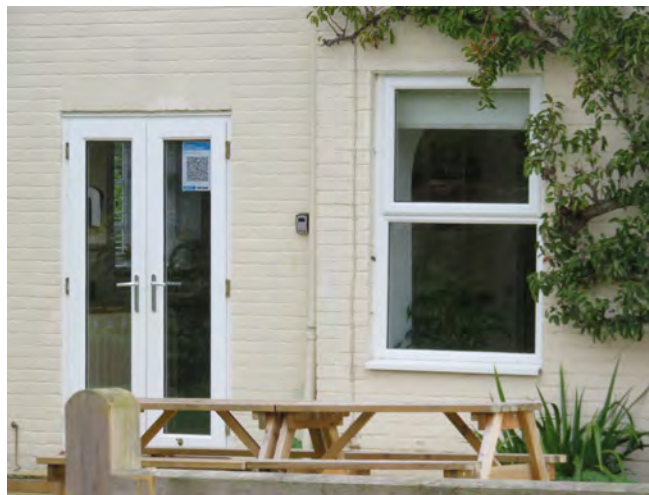
Inappropriate uPVC door and window

It is preferable to repair damaged windows and to undertake regular maintenance to ensure their enduring longevity. Well executed like-for-like replacement windows (i.e. same size and proportions of elements constructed using the same materials and finishes as the existing) maintain the aesthetic, though not the evidential value, of the historic windows. It can also be possible with some windows to incorporate slimline double-glazing to traditional style timber windows without affecting the appearance substantially. uPVC windows should not be used in historic buildings in a Conservation Area and are undesirable on modern buildings within the

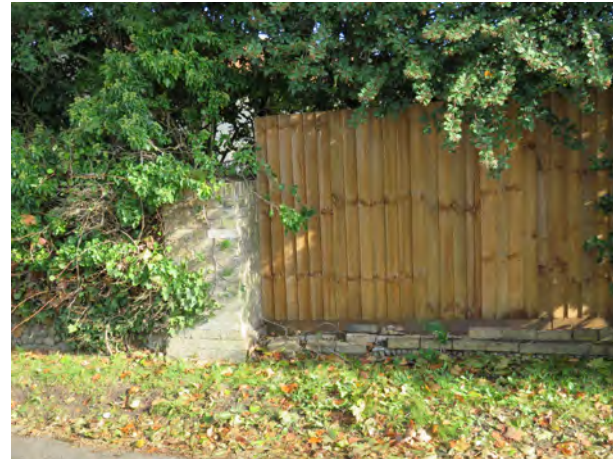
Board fencing has been used to replace a historic wall

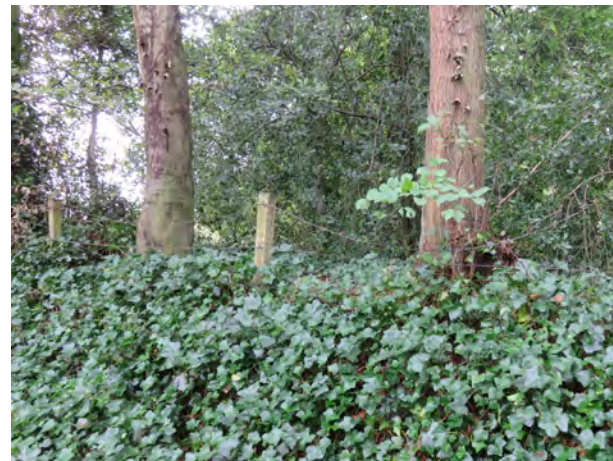
Poor quality post and barbed wire fence in poor condition

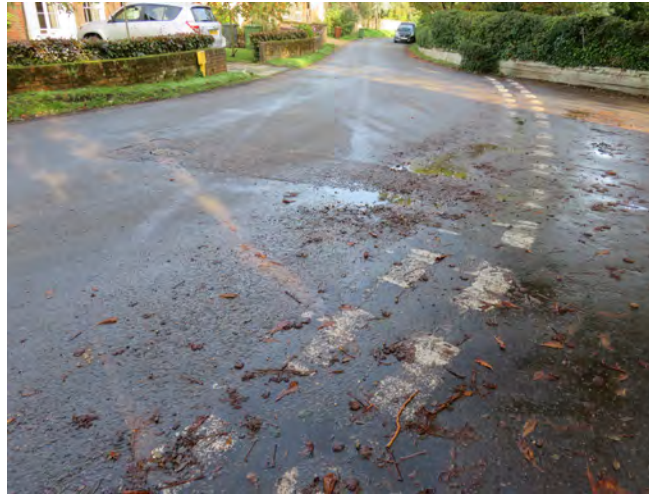
Patched road surface

The main road through Brinton has areas where it is breaking up at the edge of the road and where it has been patch filled for laying of services or repairs. This creates an untidy appearance. Similarly verges get worn to mud where cars try to pass on relatively narrow roads.
