# VERIFICATION REQUIREMENTS FOR COVER SYSTEMS

Technical Guidance for  
Developers,  
Landowners and  
Consultants

**Yorkshire and Lincolnshire  
Pollution Advisory Group**

Version 4.1 – June 2021

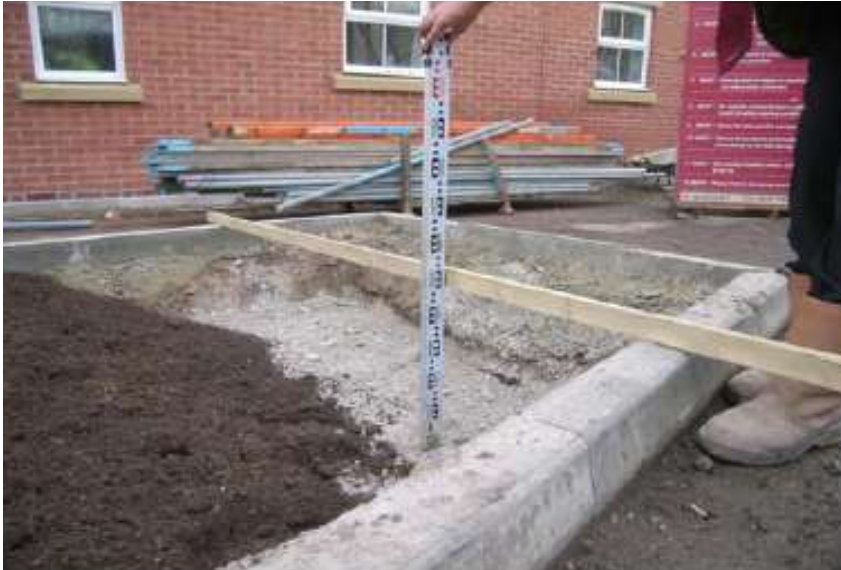
Photograph 1:  
Depth check of inert  
cover within area of  
public open space.  
Physical break layer  
and topsoil visible.

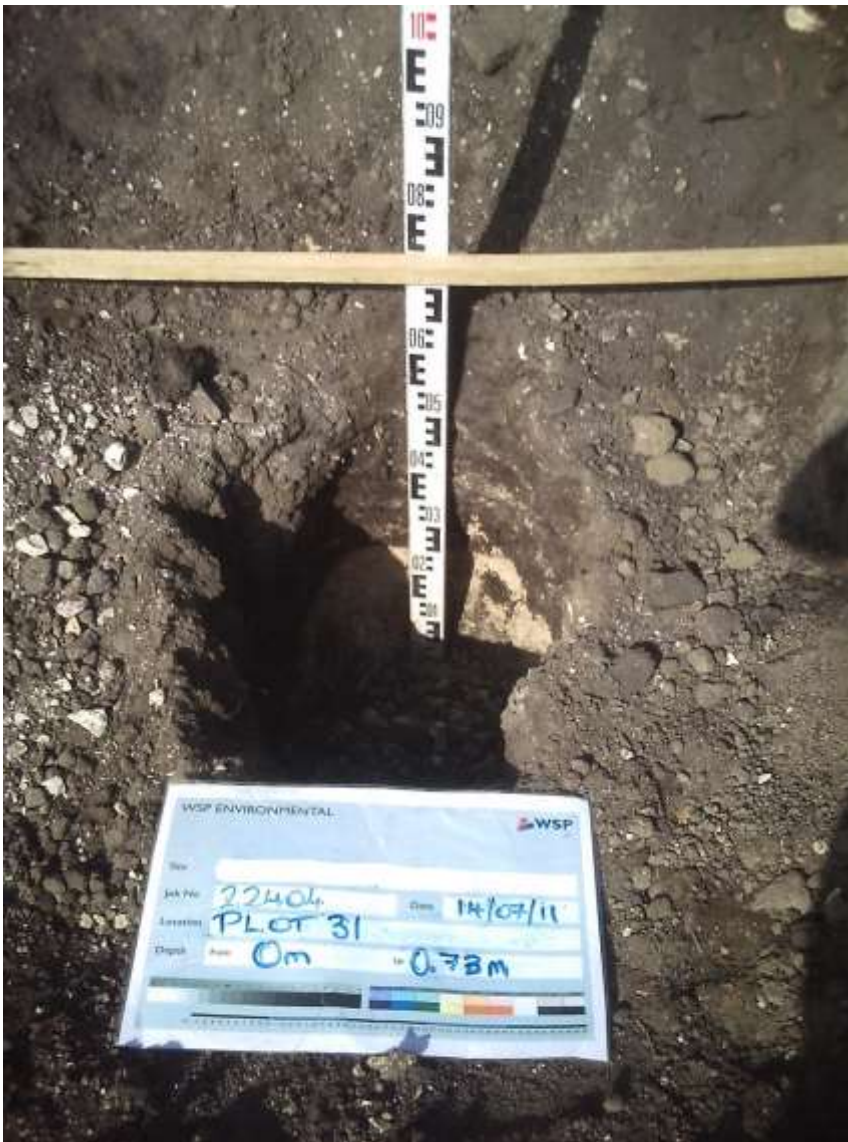
Photograph 2:  
Depth check of inert  
cover with Site &  
Location Information  
Board.

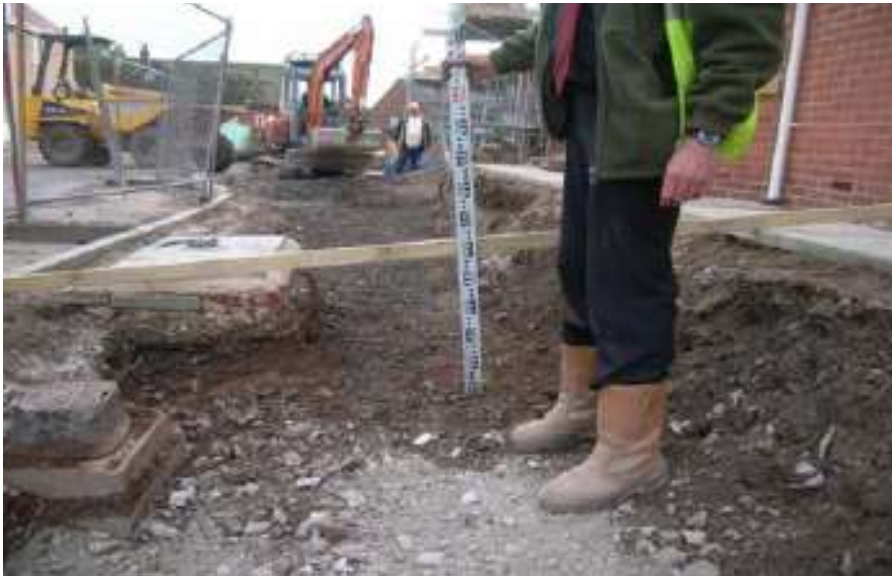
Photograph 3:  
Depth check of inert cover within areas of front gardens.

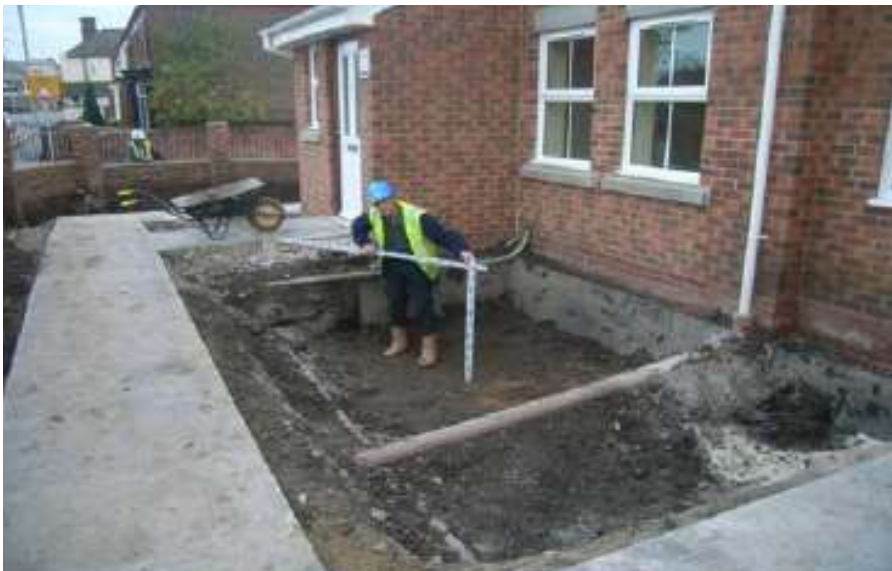
Photograph 4:  
Depth check of inert cover within areas of front gardens.

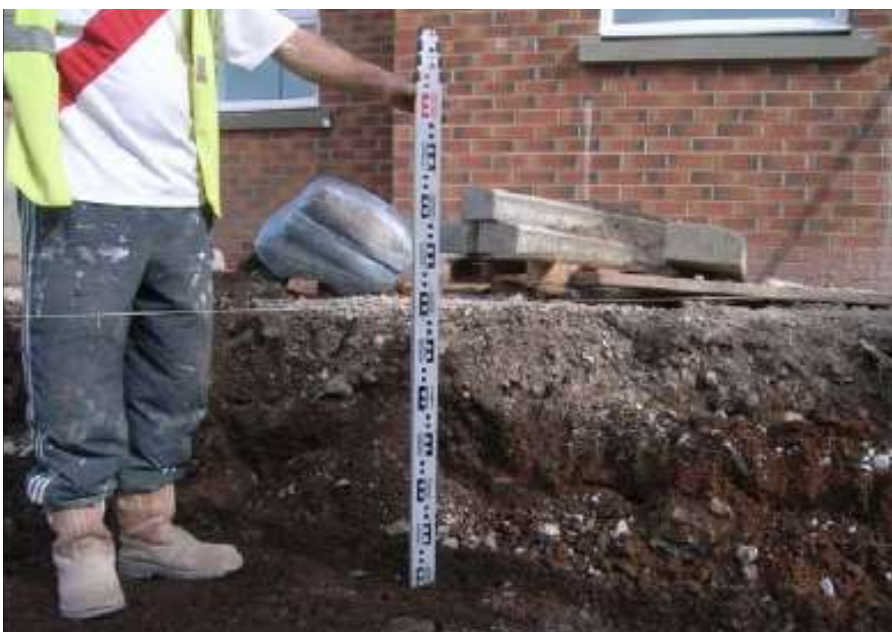
Photograph 5:  
Depth check of inert cover within rear gardens. Taut string line spans across excavation.

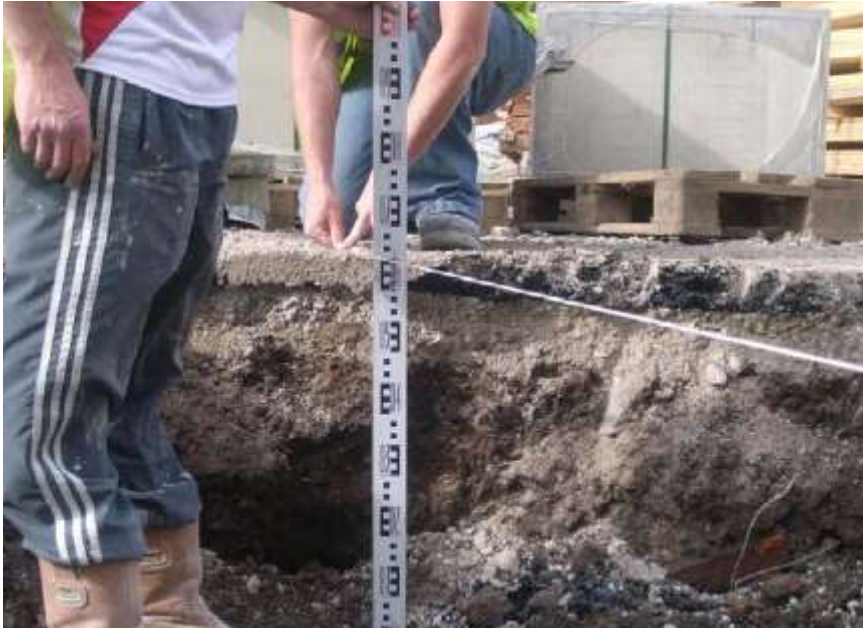
Photograph 6:  
Depth check of inert  
cover within rear  
gardens. Taut string  
line spans across  
excavation.

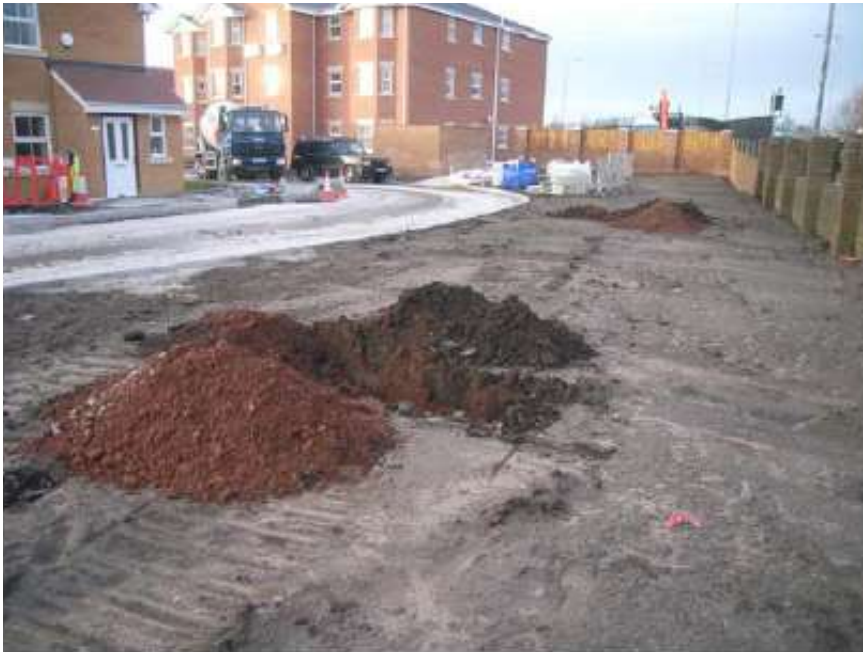
Photograph 7:  
Shows the spatial  
location of the  
verification pit.

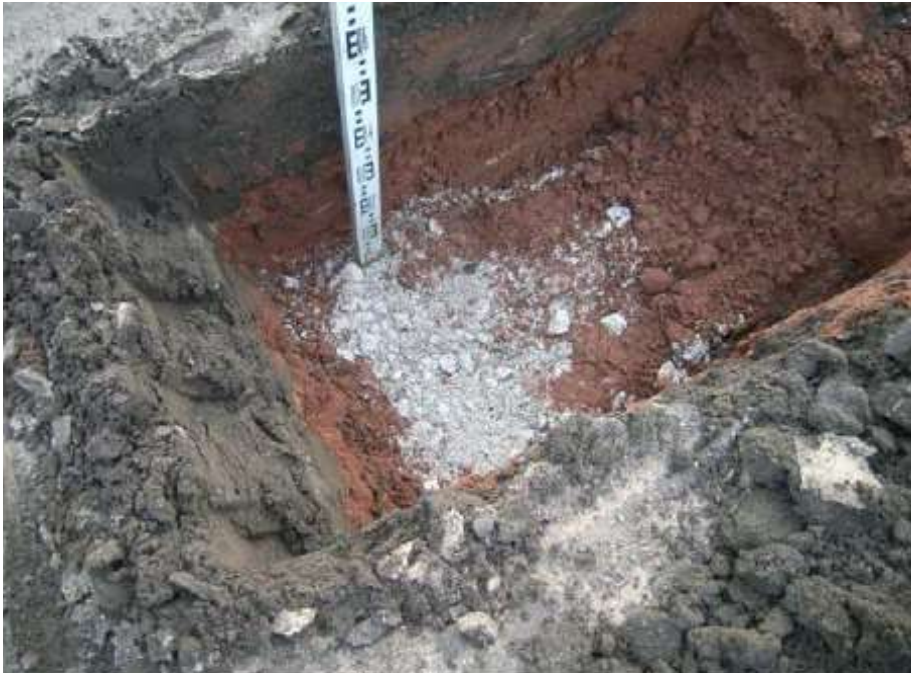
Photograph 8: Excavation within public open space and verification pit showing the presence of a remediation break layer at the base, a crushed sandstone inert fill overlain by topsoil.

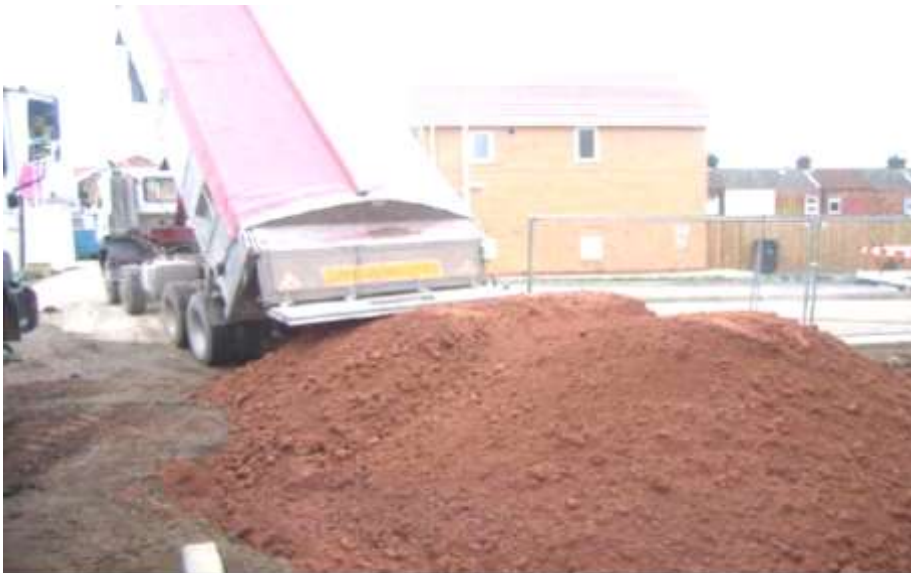
Photograph 9: Inert crushed sandstone being delivered. The spatial area of the remediation can be observed from these photographs (old terrace housing).

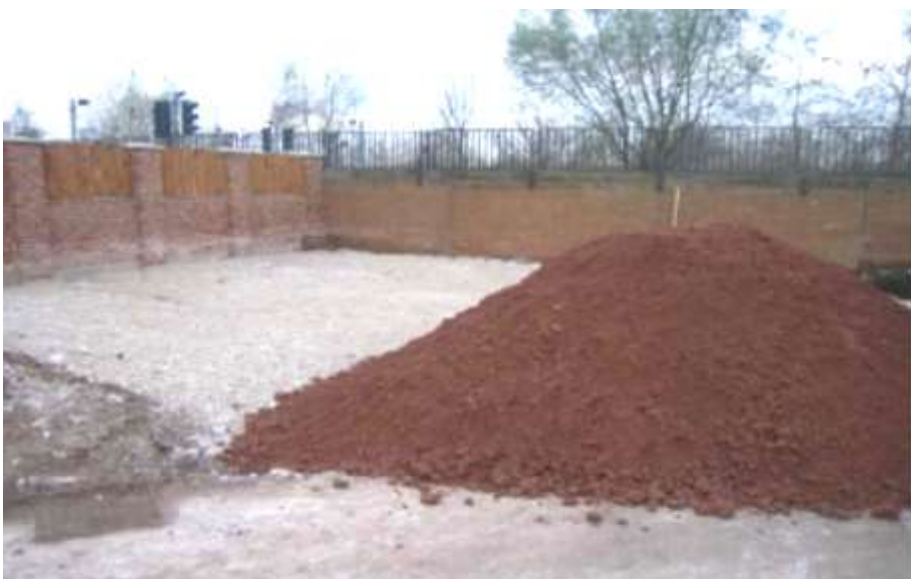
Photograph 10: Inert crushed sandstone being delivered with visible remediation break layer. The spatial area of the remediation can be observed from these photographs (traffic lights).

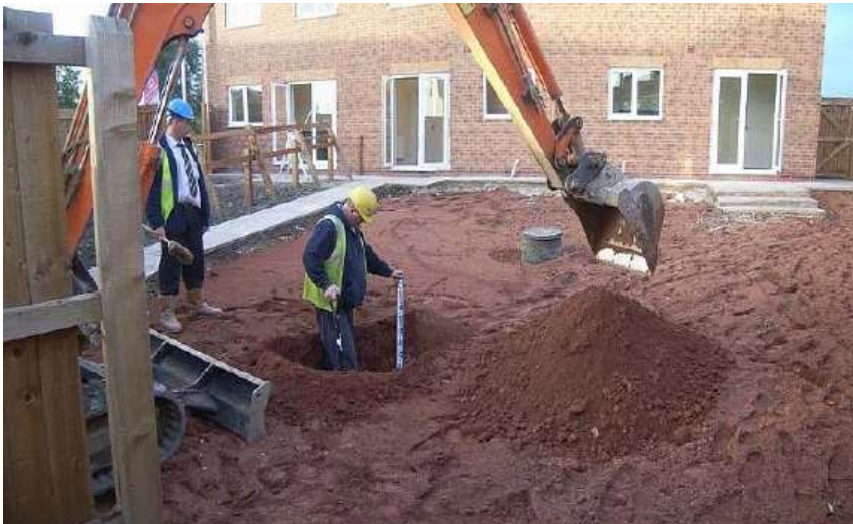
Photograph 11:  
Shows the remediation of the rear garden, with a significant depth (1.0m) of inert cover. This photograph has been stitched to form a panoramic photograph and hence there is slight distortion

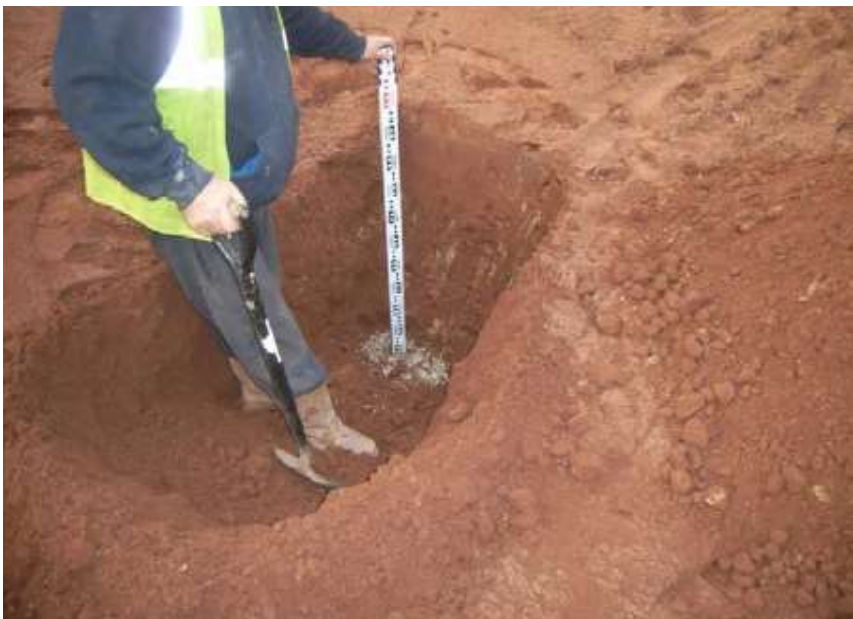
Photograph 12:  
Shows the remediation of the rear garden, with a significant depth (1.0m) of inert cover. Remediation break layer visible at the base of the excavation.
