HERITAGE STATEMENT

This Application relates to the Shannoeks Hotel building at No. 1 High Street, Sheringham.

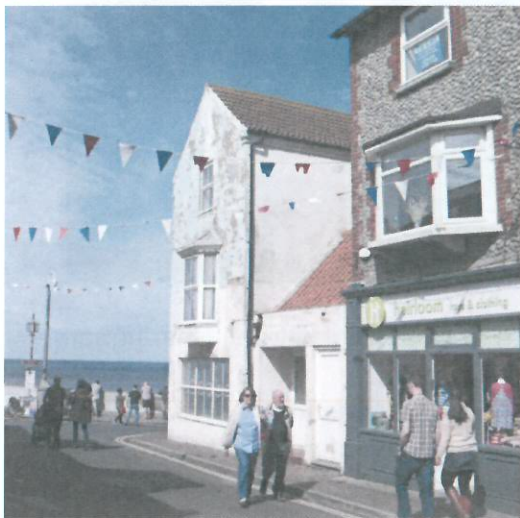
The other street frontage, at High Street, includes a three storey gable wall with central octagonal oriel window at the first floor. At the South end of this frontage a modern, single storey element with clay pantile roof and parapet provides a side entrance which relates to a modern accommodation stair adjacent the internal party wall with No. 3 High Street.

West Elevation to High Street

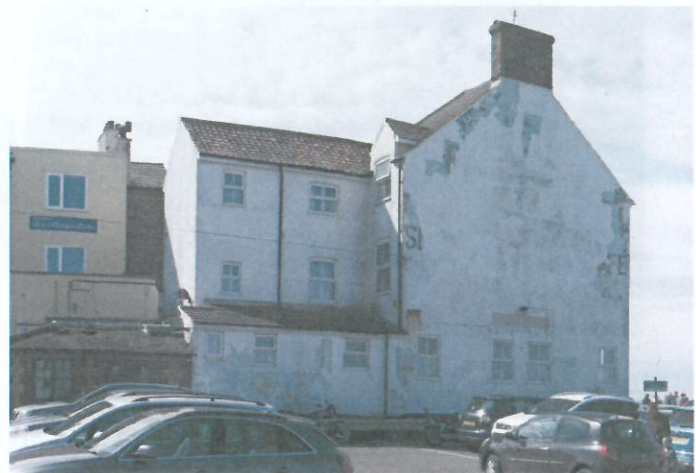
The East side frontage relates to the Chequers car park. The elevation is rendered, a tall, mostly blank gable with central chimney and some modern windows at the ground floor. At the rear side another three storey wing presents a blank gable to its South end with, at the East side, a single storey element with pitched roof and windows to the upper floors.

East Elevation to Chequers Car Park
